REPORT NUMBER 214-GTL-04-003

**SAFETY COMPLIANCE TESTING FOR  
FMVSS NO. 214S  
SIDE IMPACT PROTECTION (STATIC)**

**GENERAL MOTORS CORP.  
2004 CHEVROLET MALIBU, PASSENGER CAR  
NHTSA NO. C40102**

**GENERAL TESTING LABORATORIES, INC.  
1623 LEEDSTOWN ROAD  
COLONIAL BEACH, VIRGINIA 22443**

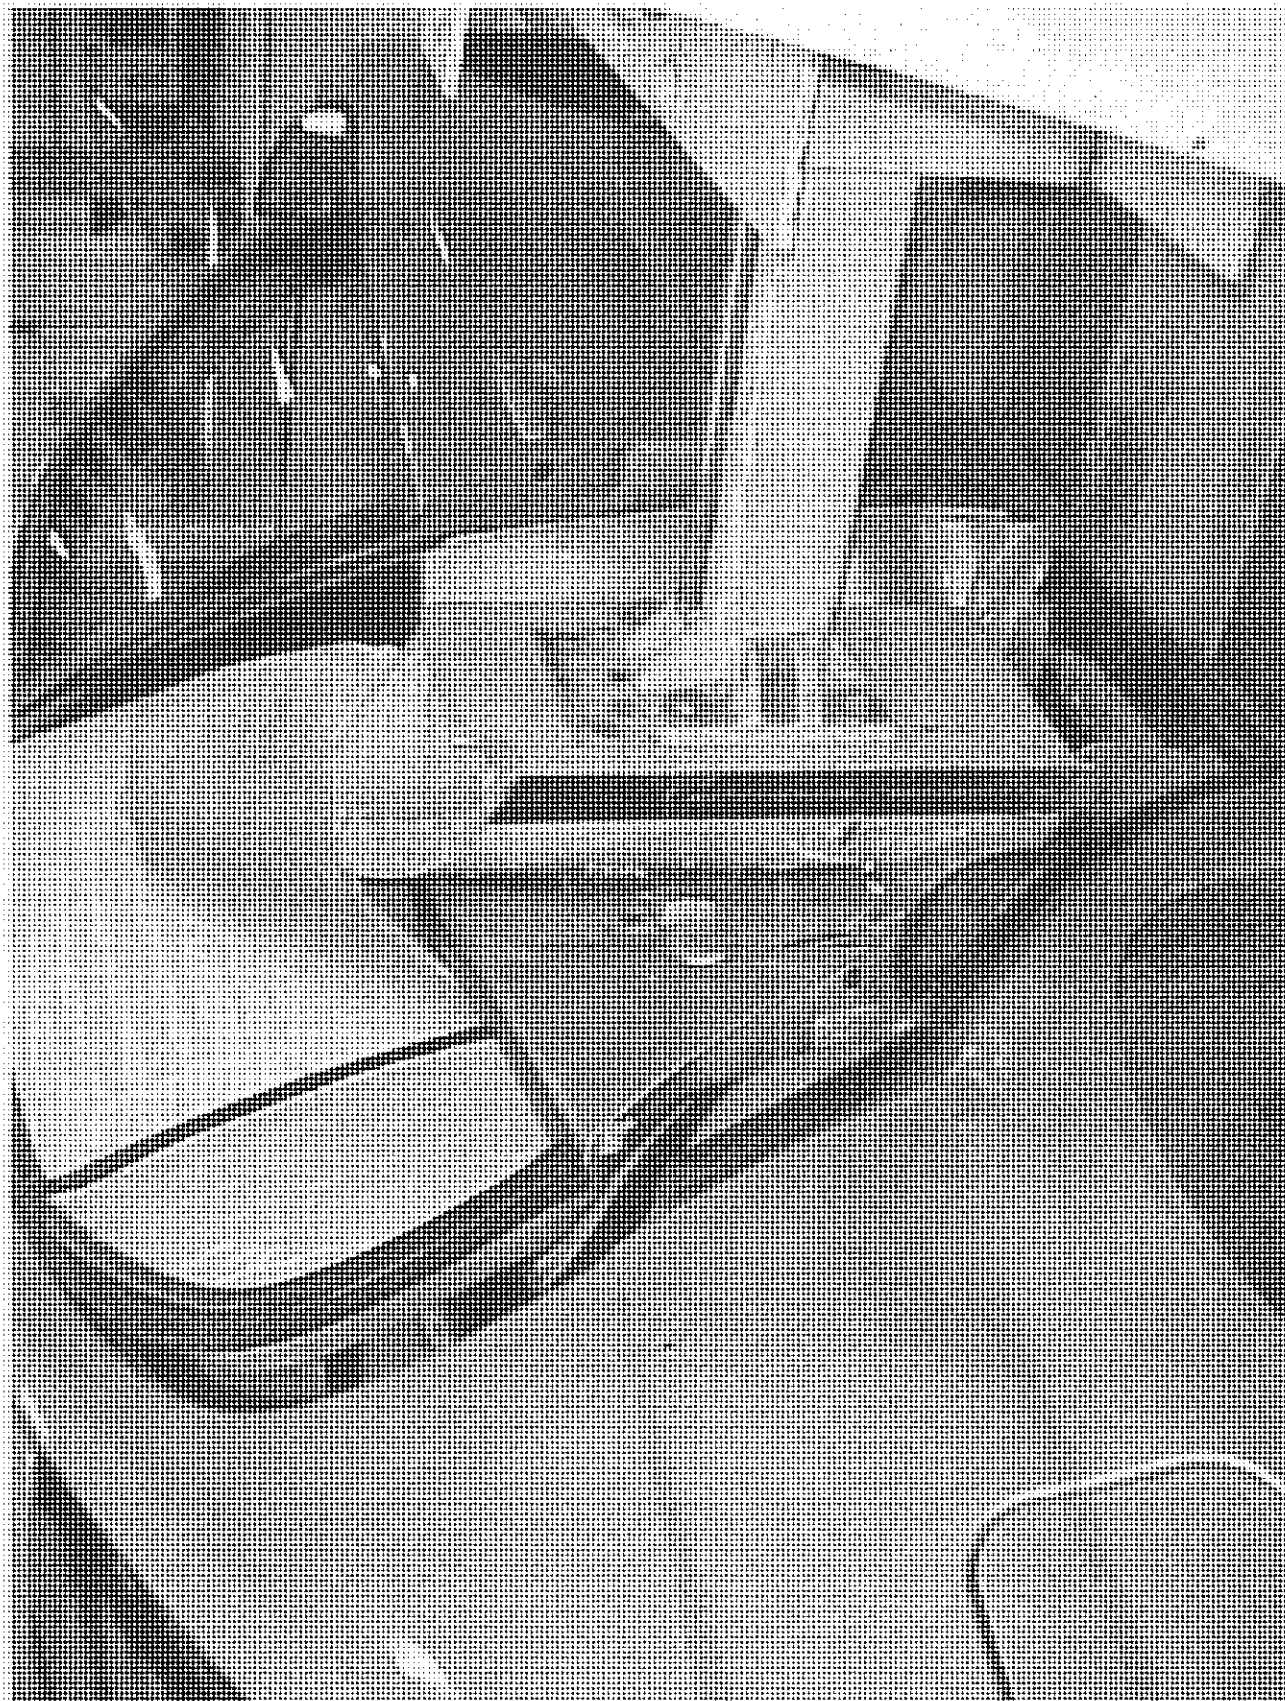
FIGURE 5.26  
LOAD DEVICE AGAINST DOOR @ MAX  
LOAD - TEST 2

| SECTION | | PAGE |
|---|---|---|
| | 5.26 Load Device against Door @ max load - Test 2 | |

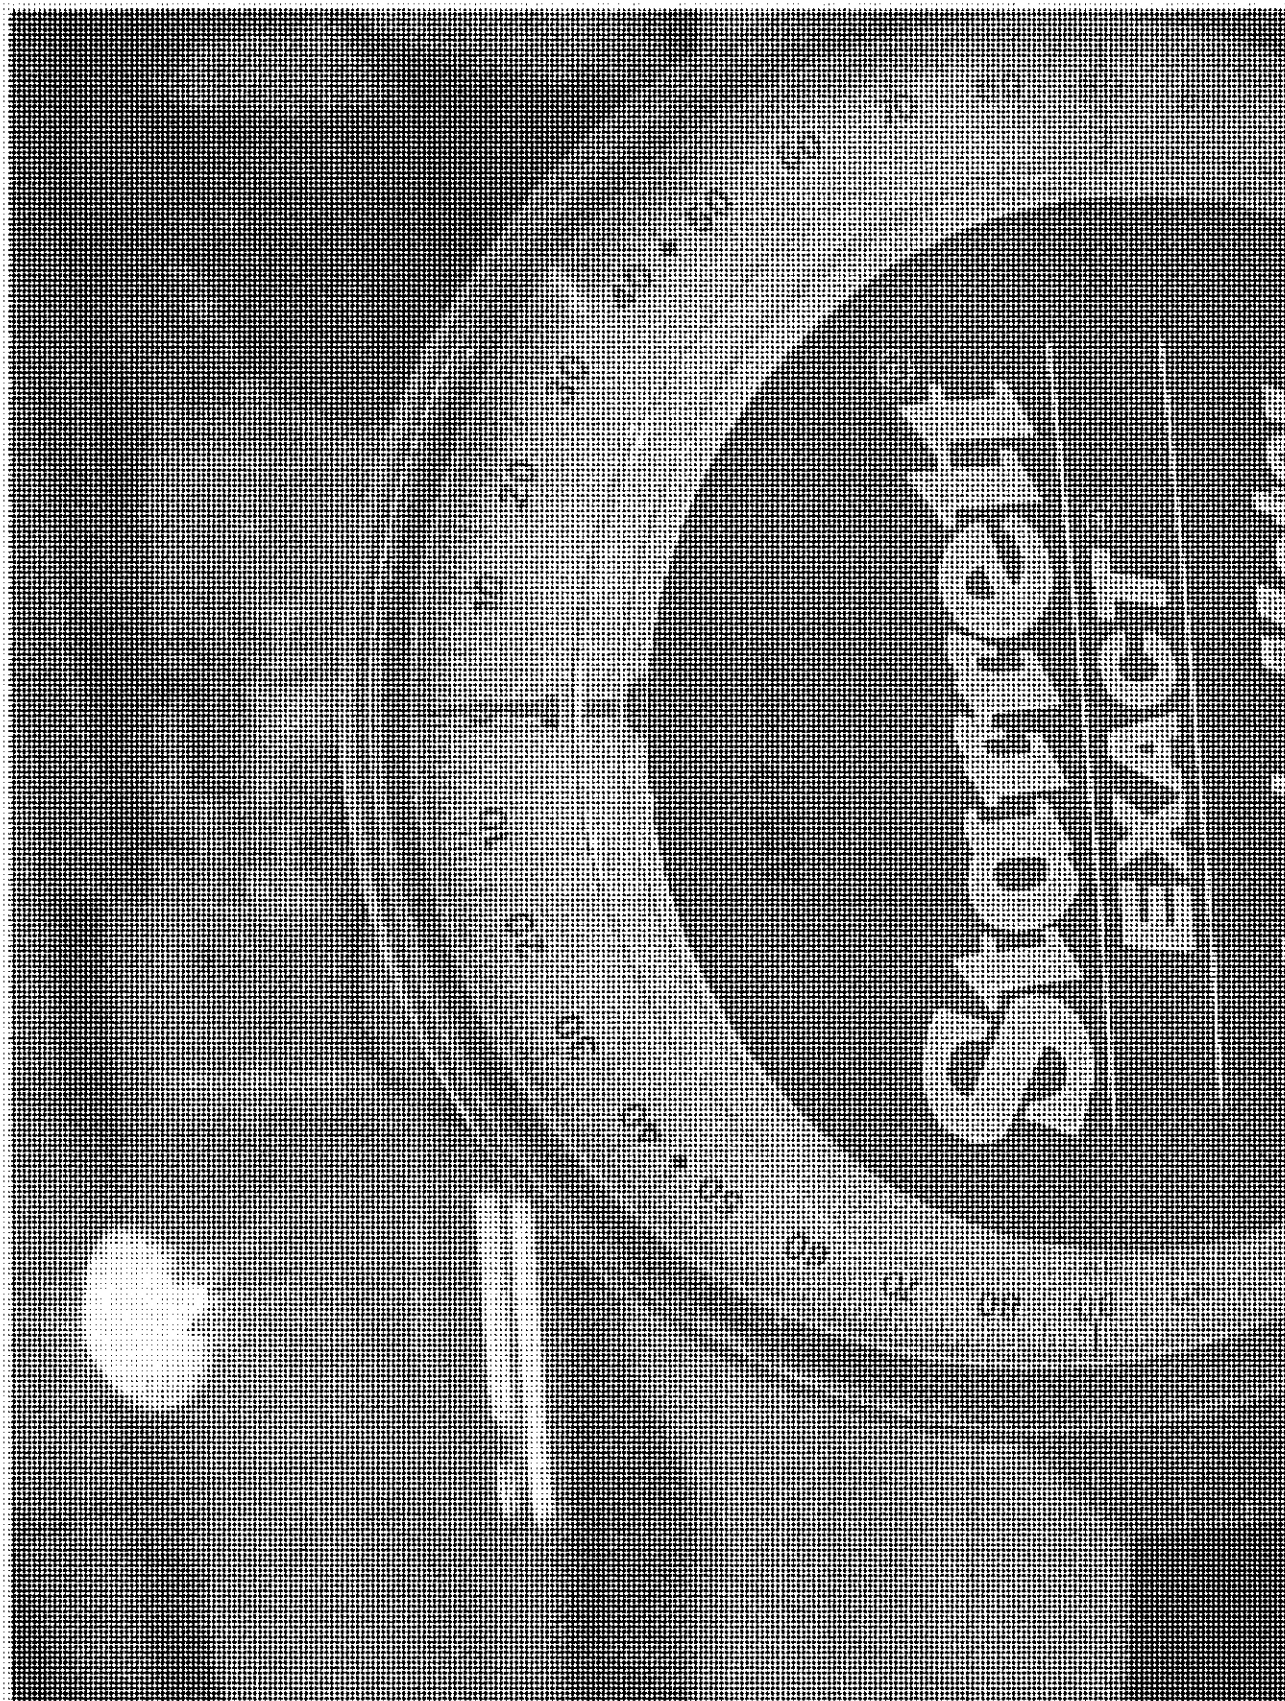
FIGURE 5.27  
INCLINOMETER AT MAX LOAD - TEST 2

| SECTION | | PAGE |
|---|---|---|
| | 5.27 Inclinator at Max Load - Test 2 | |

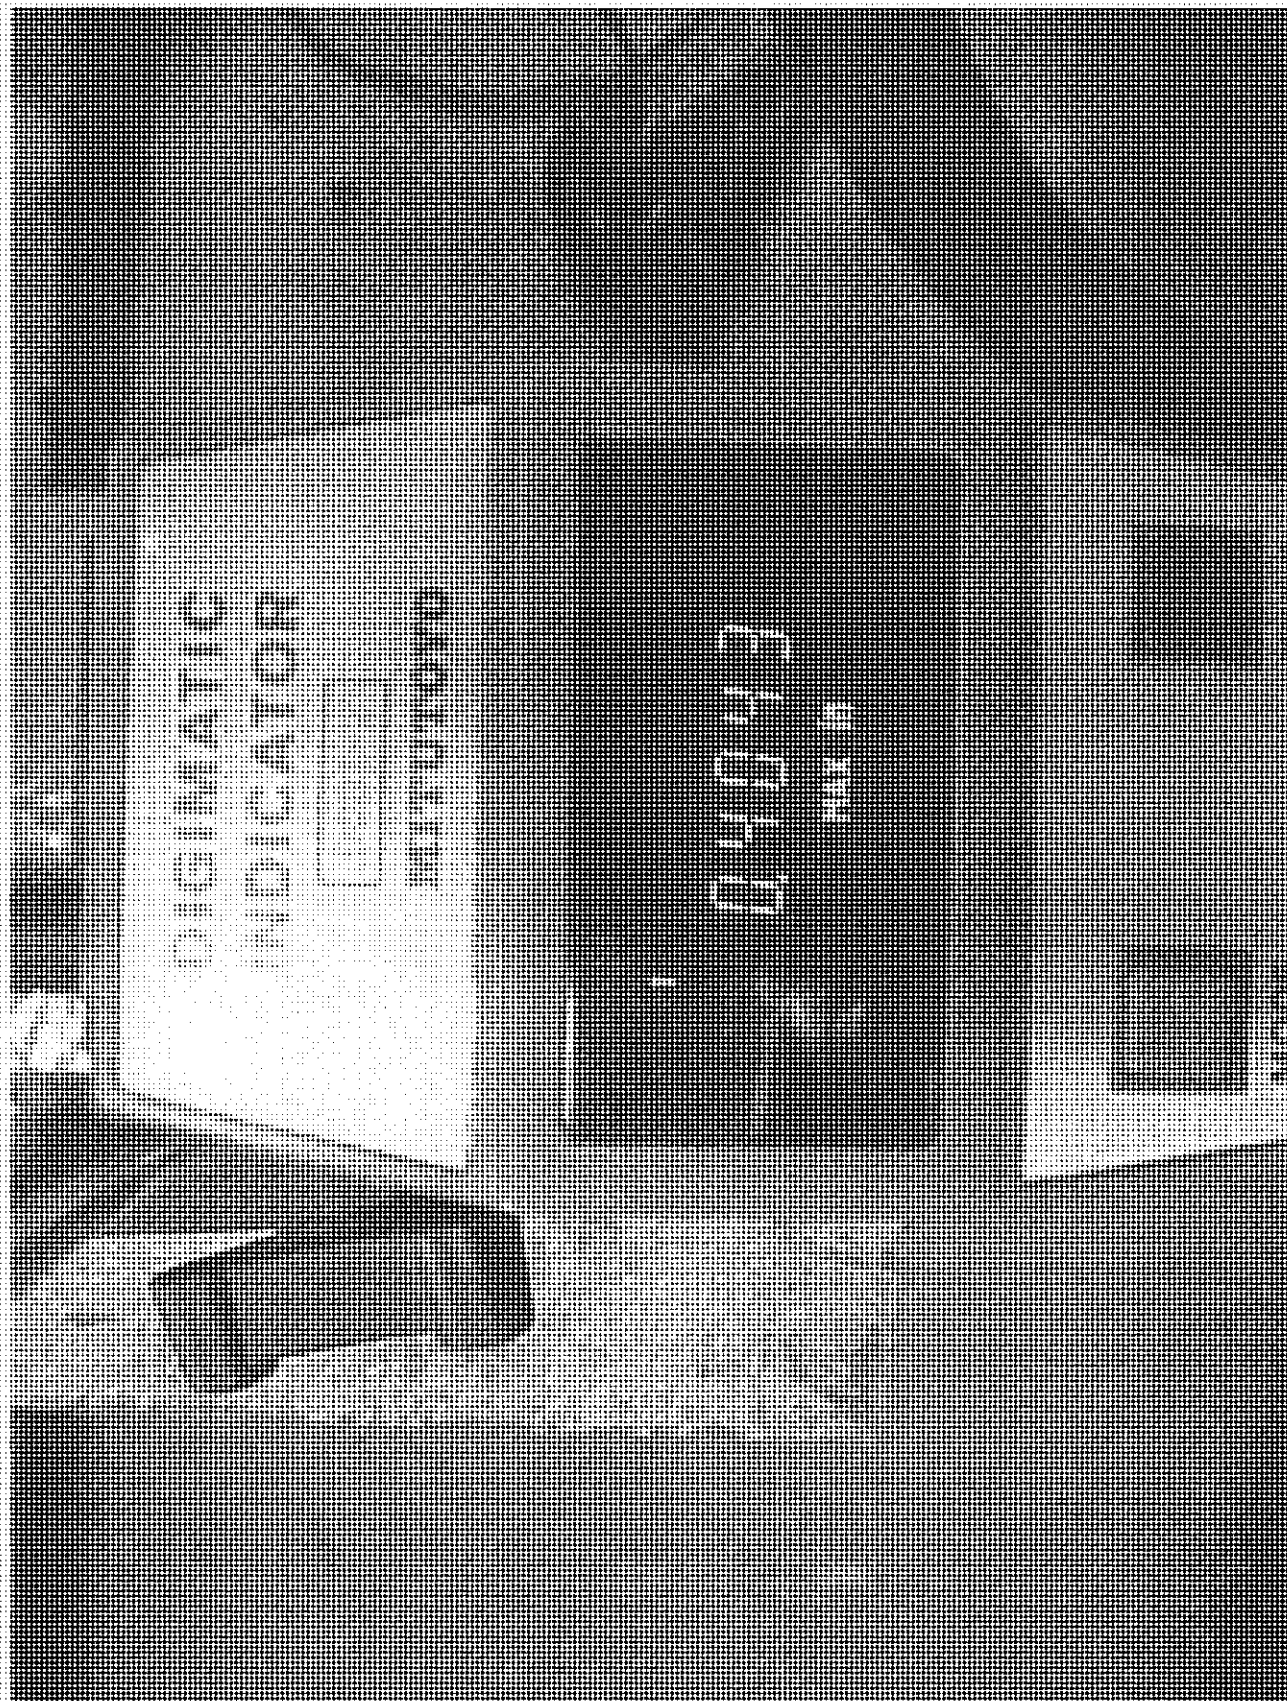
FIGURE 5.23  
DIAL INDICATOR AT MAX LOAD - TEST 2

| SECTION | | PAGE |
|---|---|---|
| | 5.28 Dial Indicator at Max Load - Test 2 | |

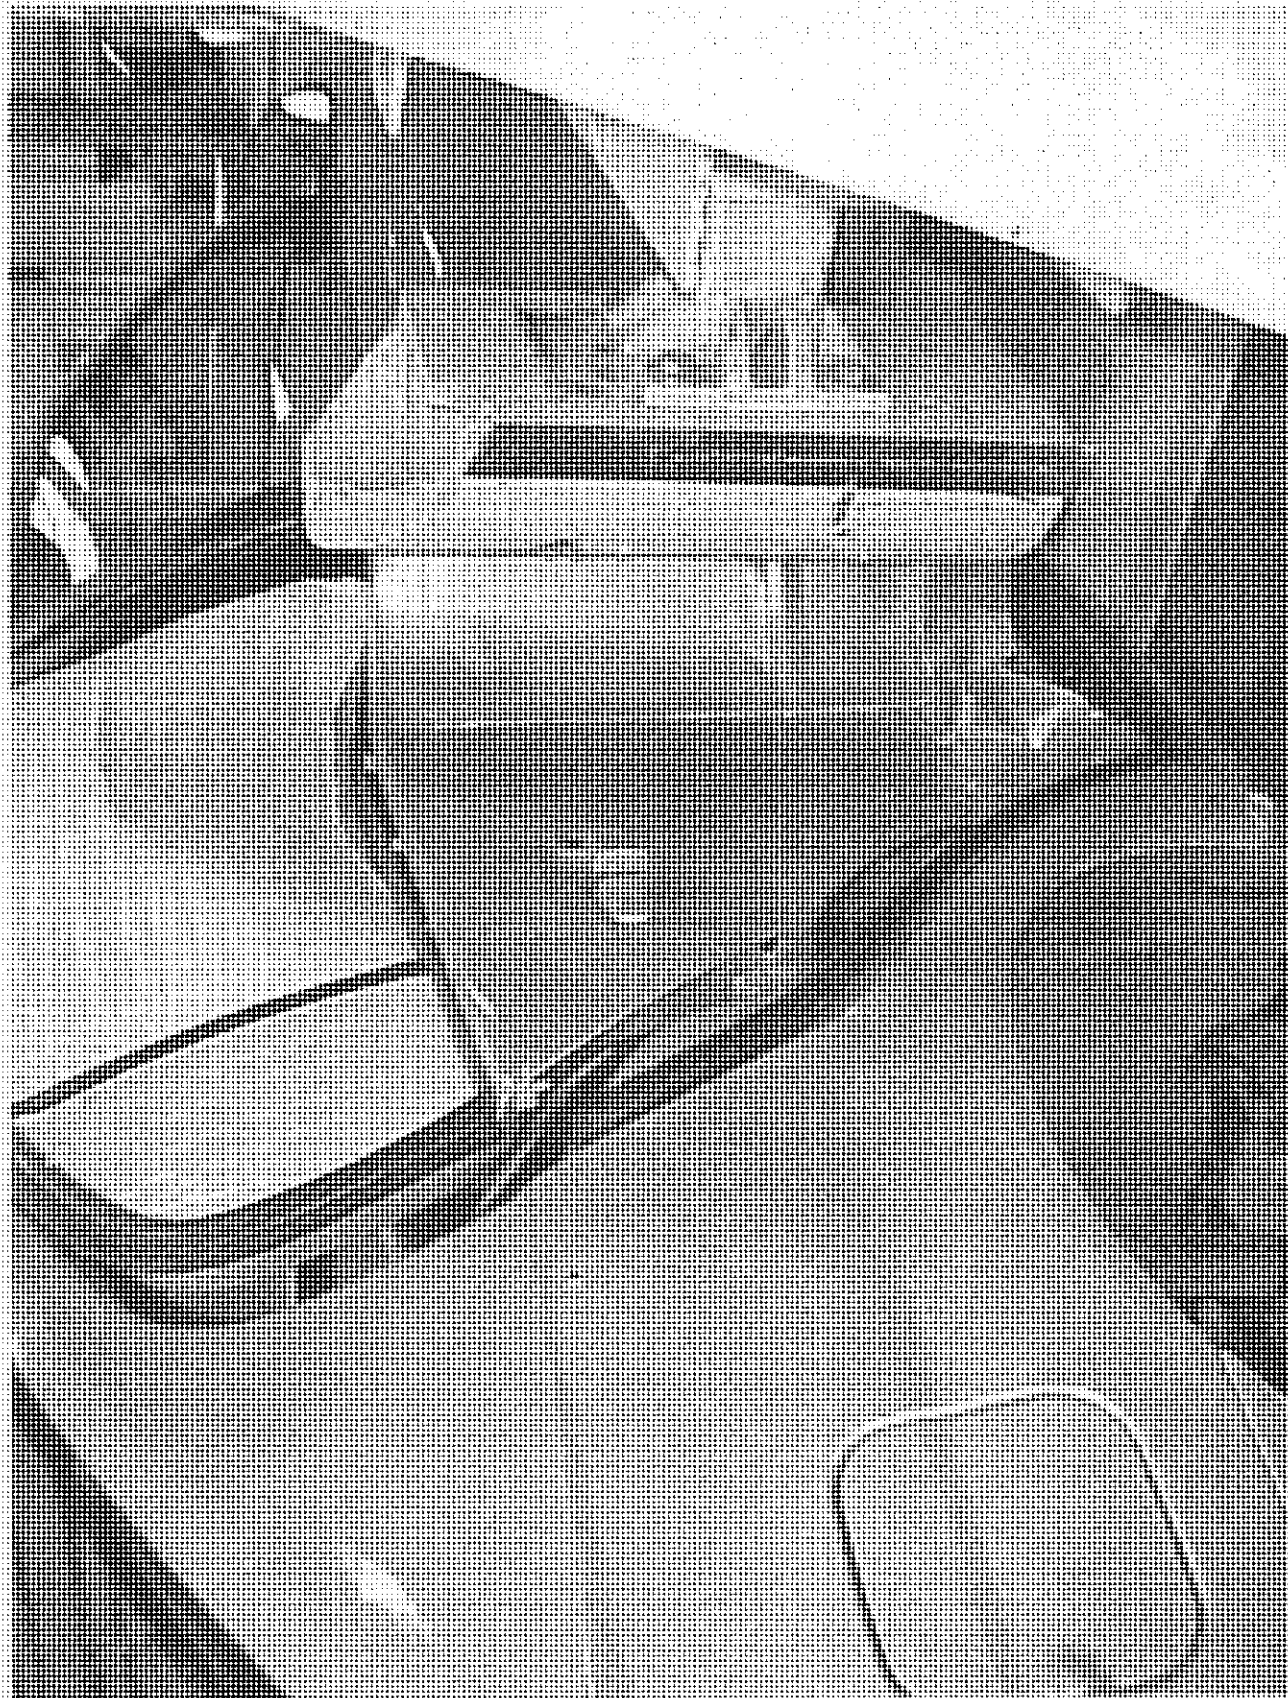
FIGURE 5.29  
POST TEST DOOR OUTSIDE - TEST 2

| SECTION | | PAGE |
|---|---|---|
| | 5.29 Post Test Door Outside - Test 2 | |

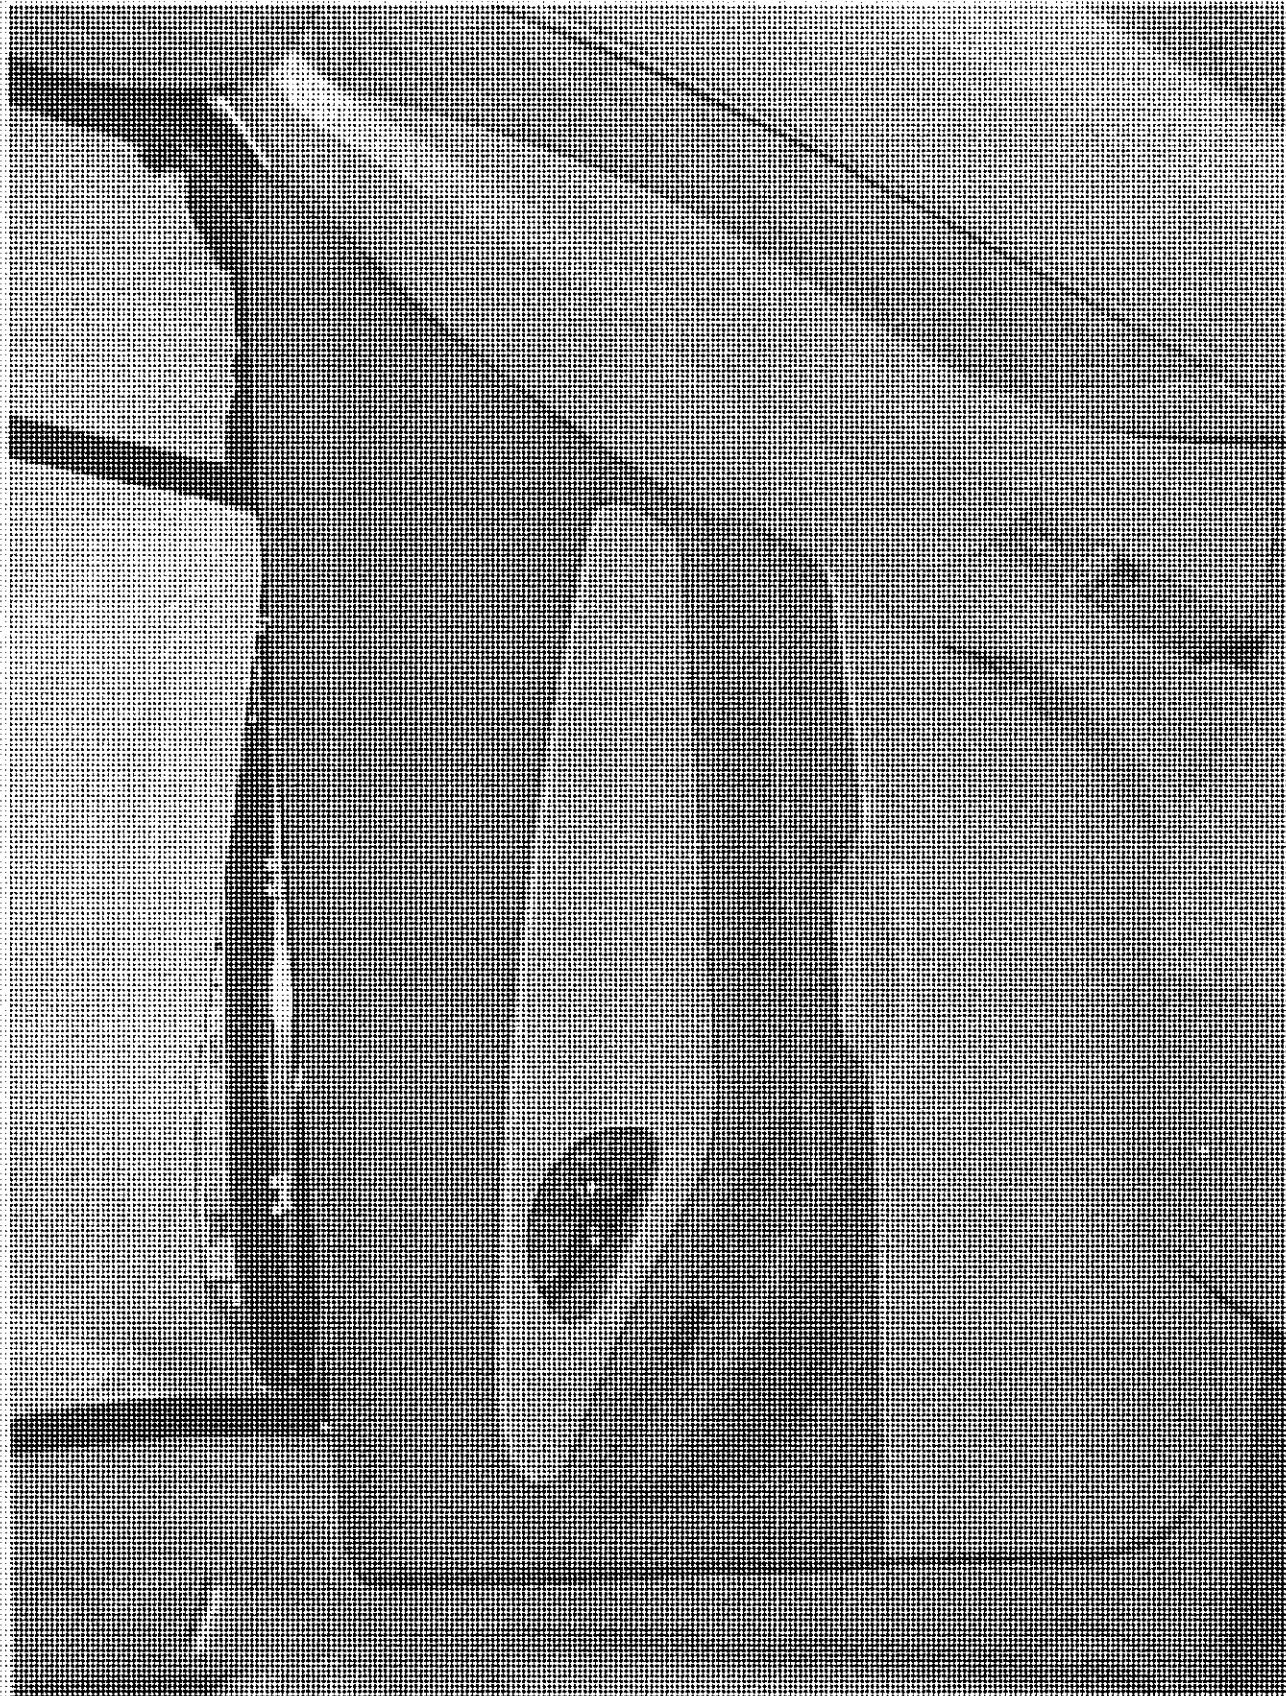
FIGURE 5.30  
POST TEST DOOR INSIDE - TEST 2

| SECTION | | PAGE |
|---|---|---|
| | 5.30 Post Test Door Inside - Test 2 | |

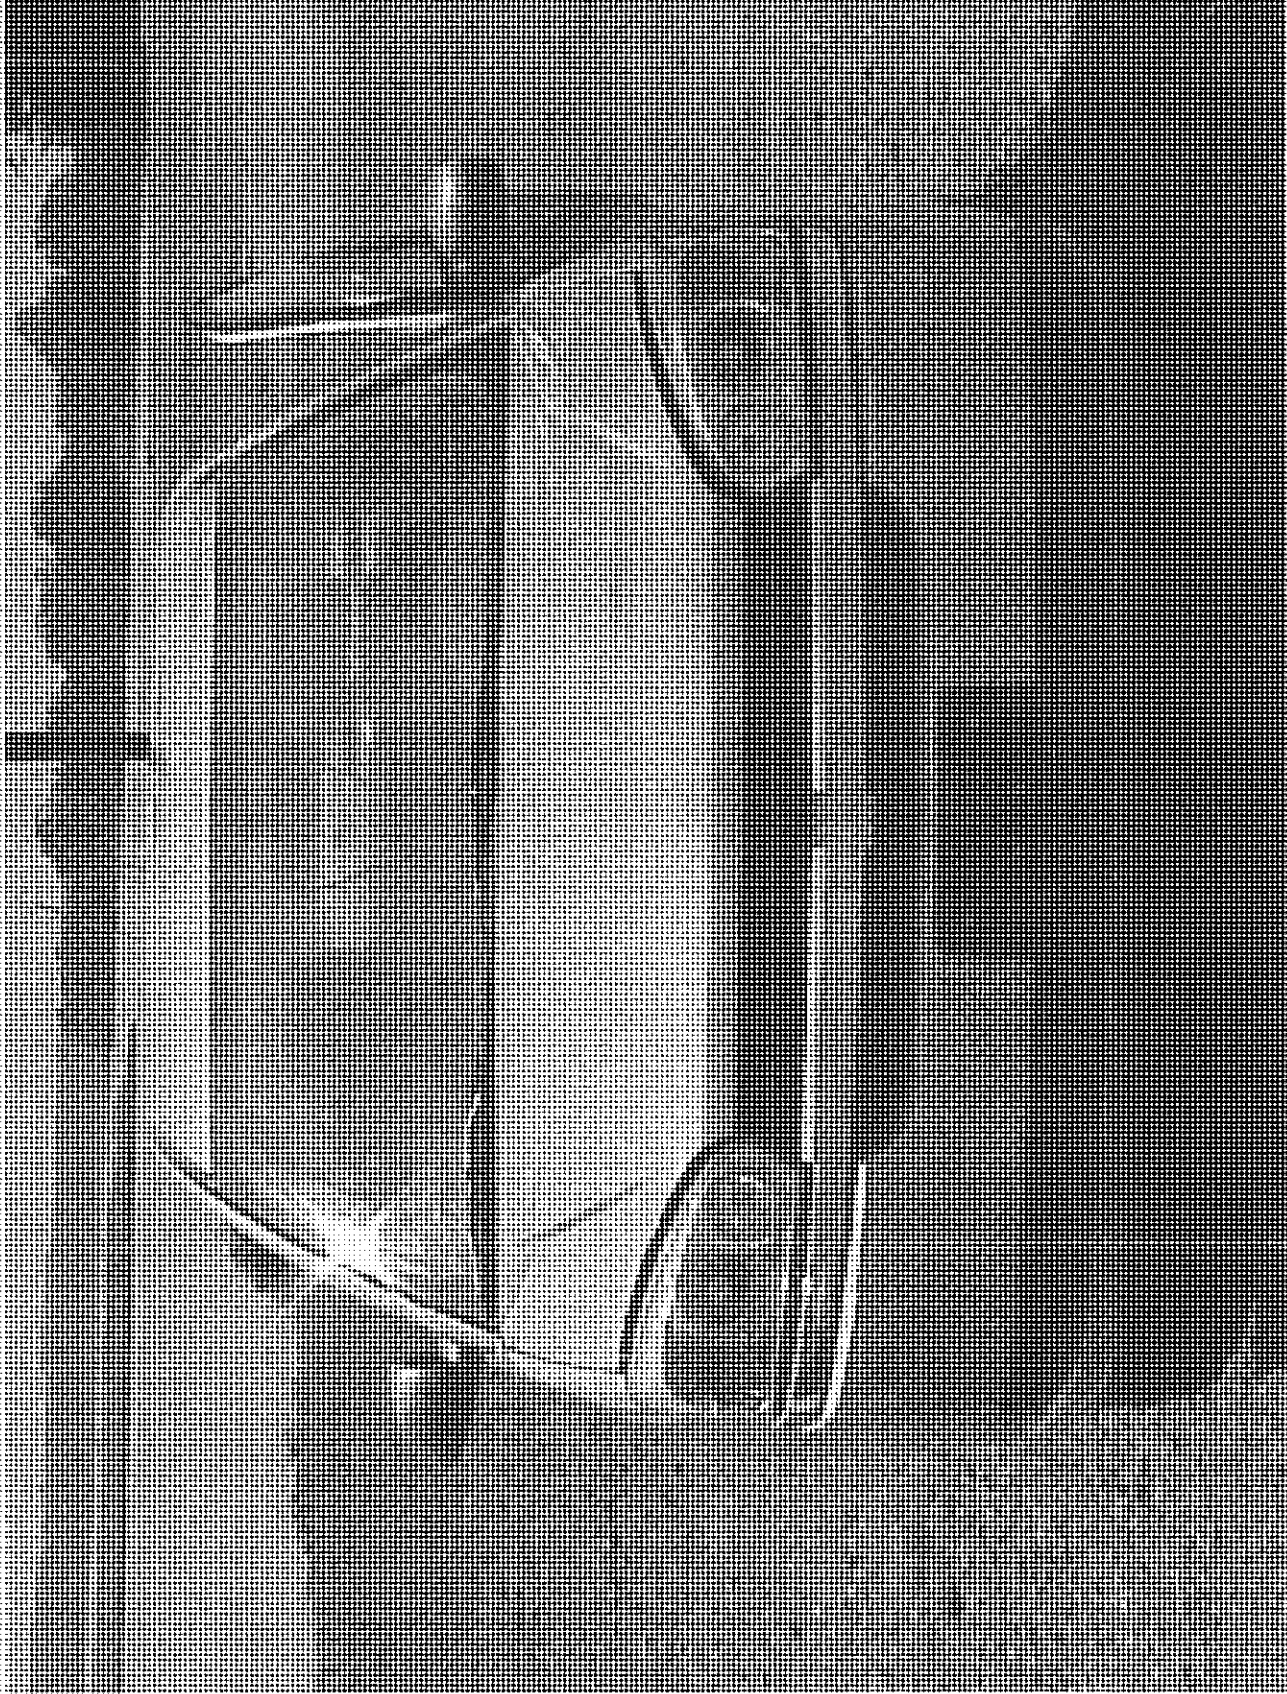
FIGURE 6-31  
FRONT VIEW OF VEHICLE POST TEST

| SECTION | | PAGE |
|---|---|---|
| | 5.31 Front View of Vehicle Post Test | |

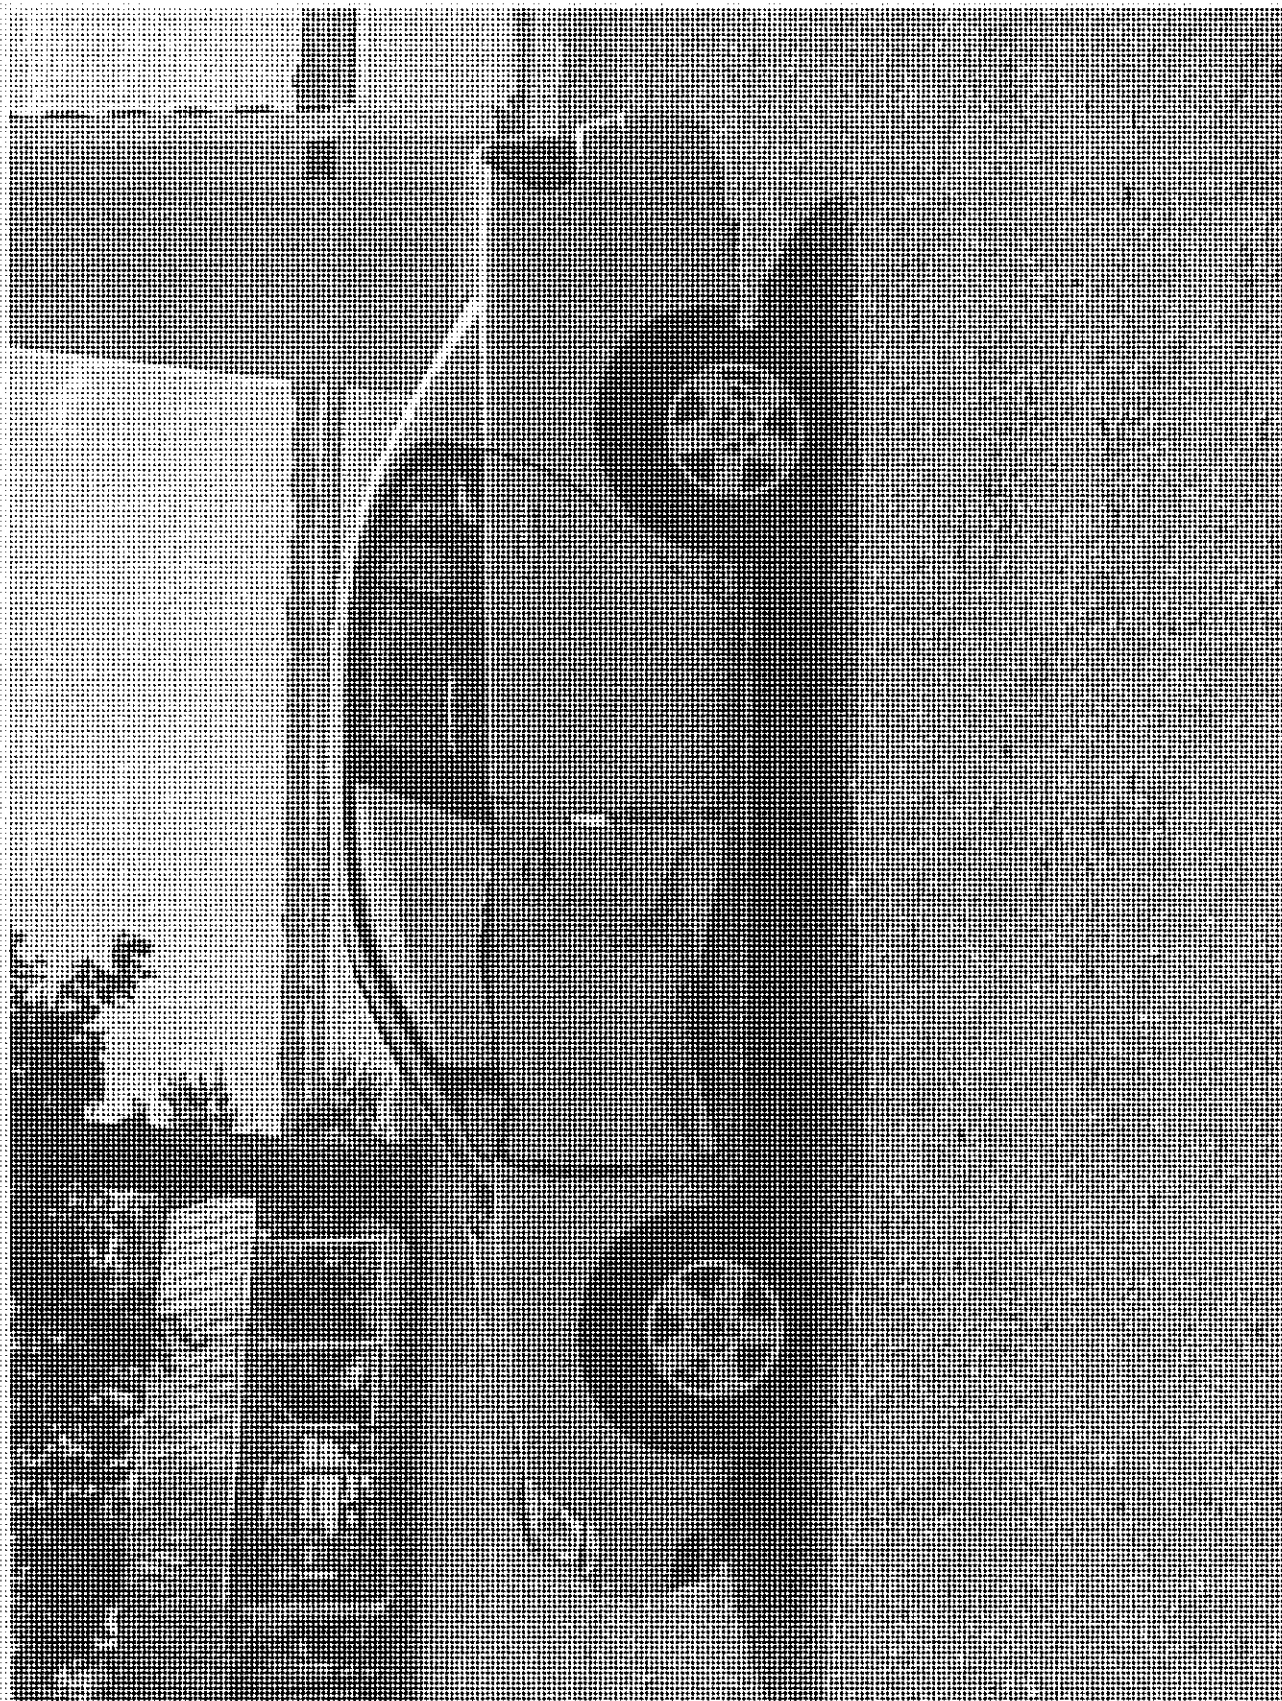
FIGURE 5.32  
LEFT SIDE VIEW OF VEHICLE POST TEST

| SECTION | | PAGE |
|---|---|---|
| | 5.32 Left Side View of Vehicle Post Test | |

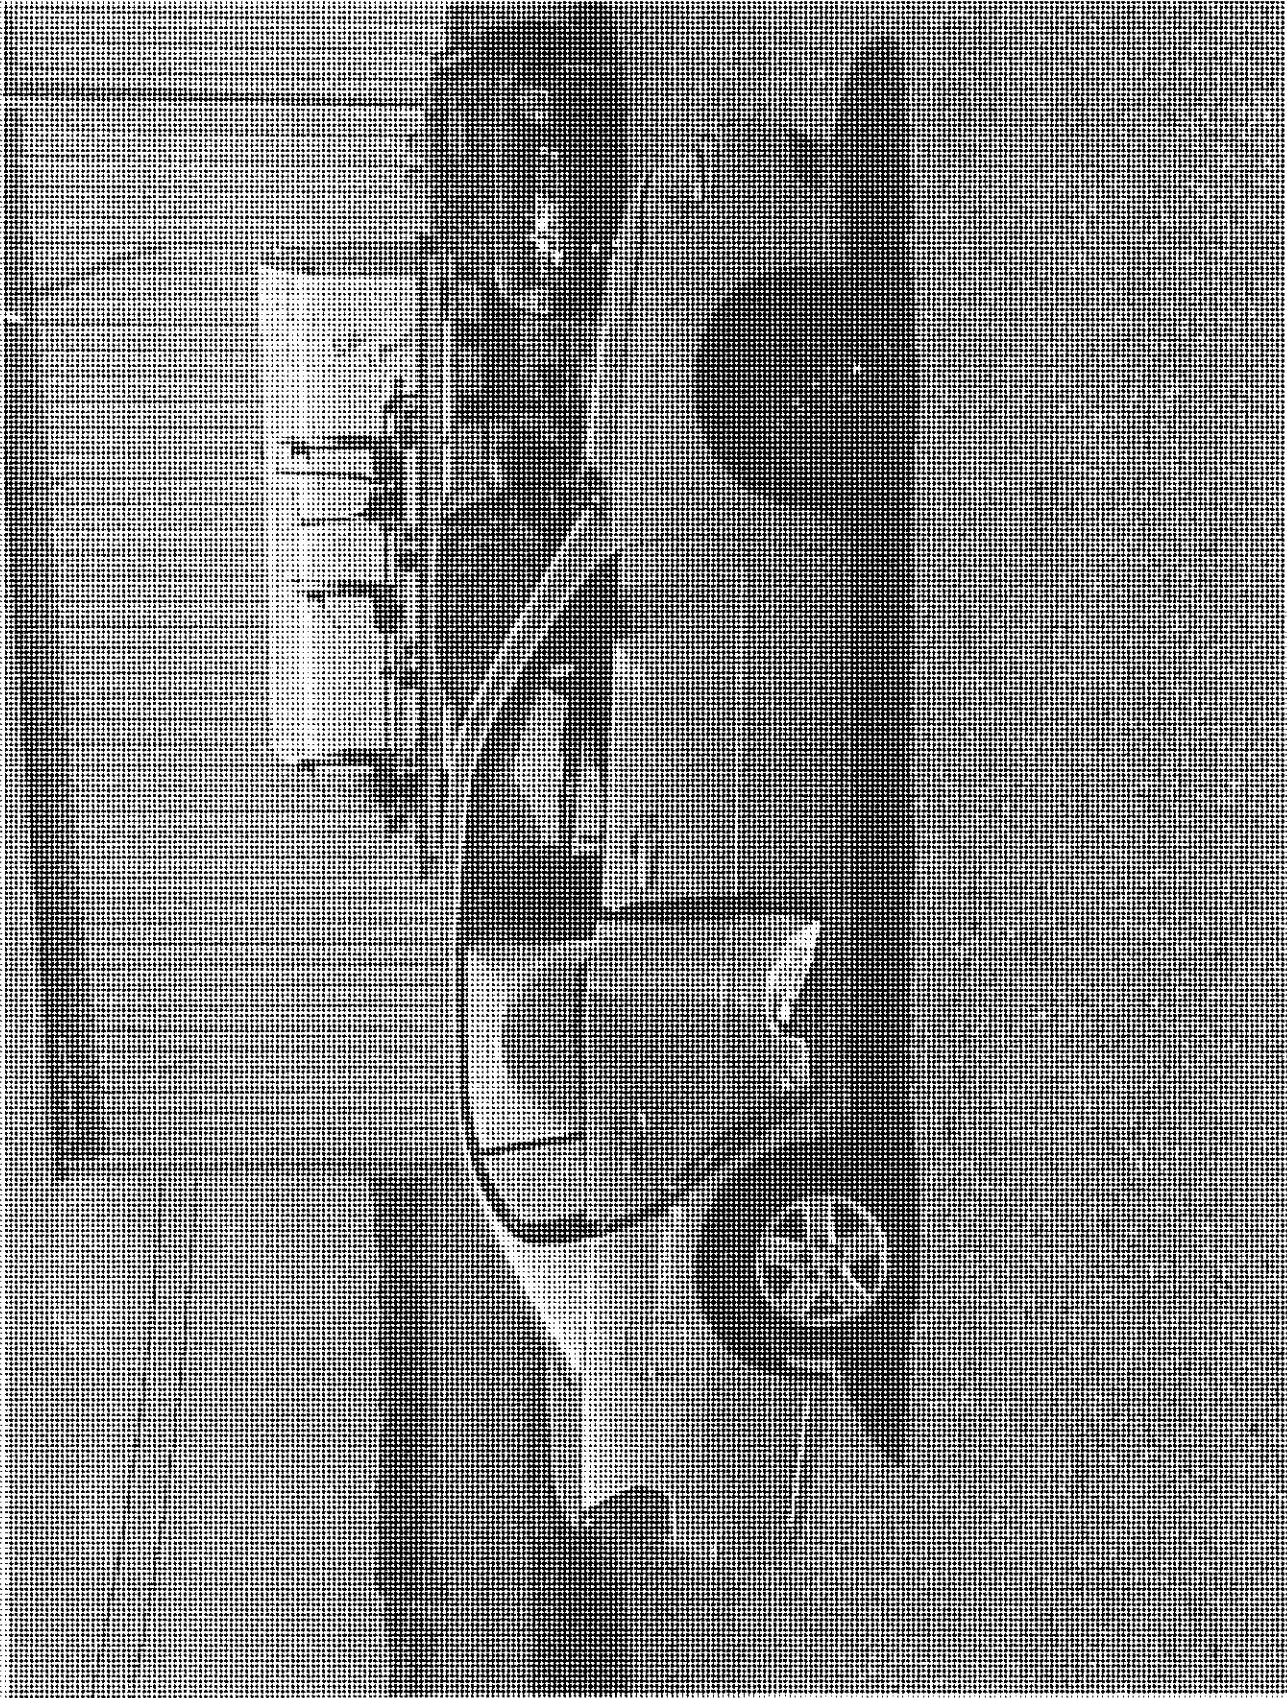
FIGURE 5.35  
RIGHT SIDE VIEW OF VEHICLE POST  
TEST

| SECTION | | PAGE |
|---|---|---|
| | 5.33 Right Side View of Vehicle Post Test | |

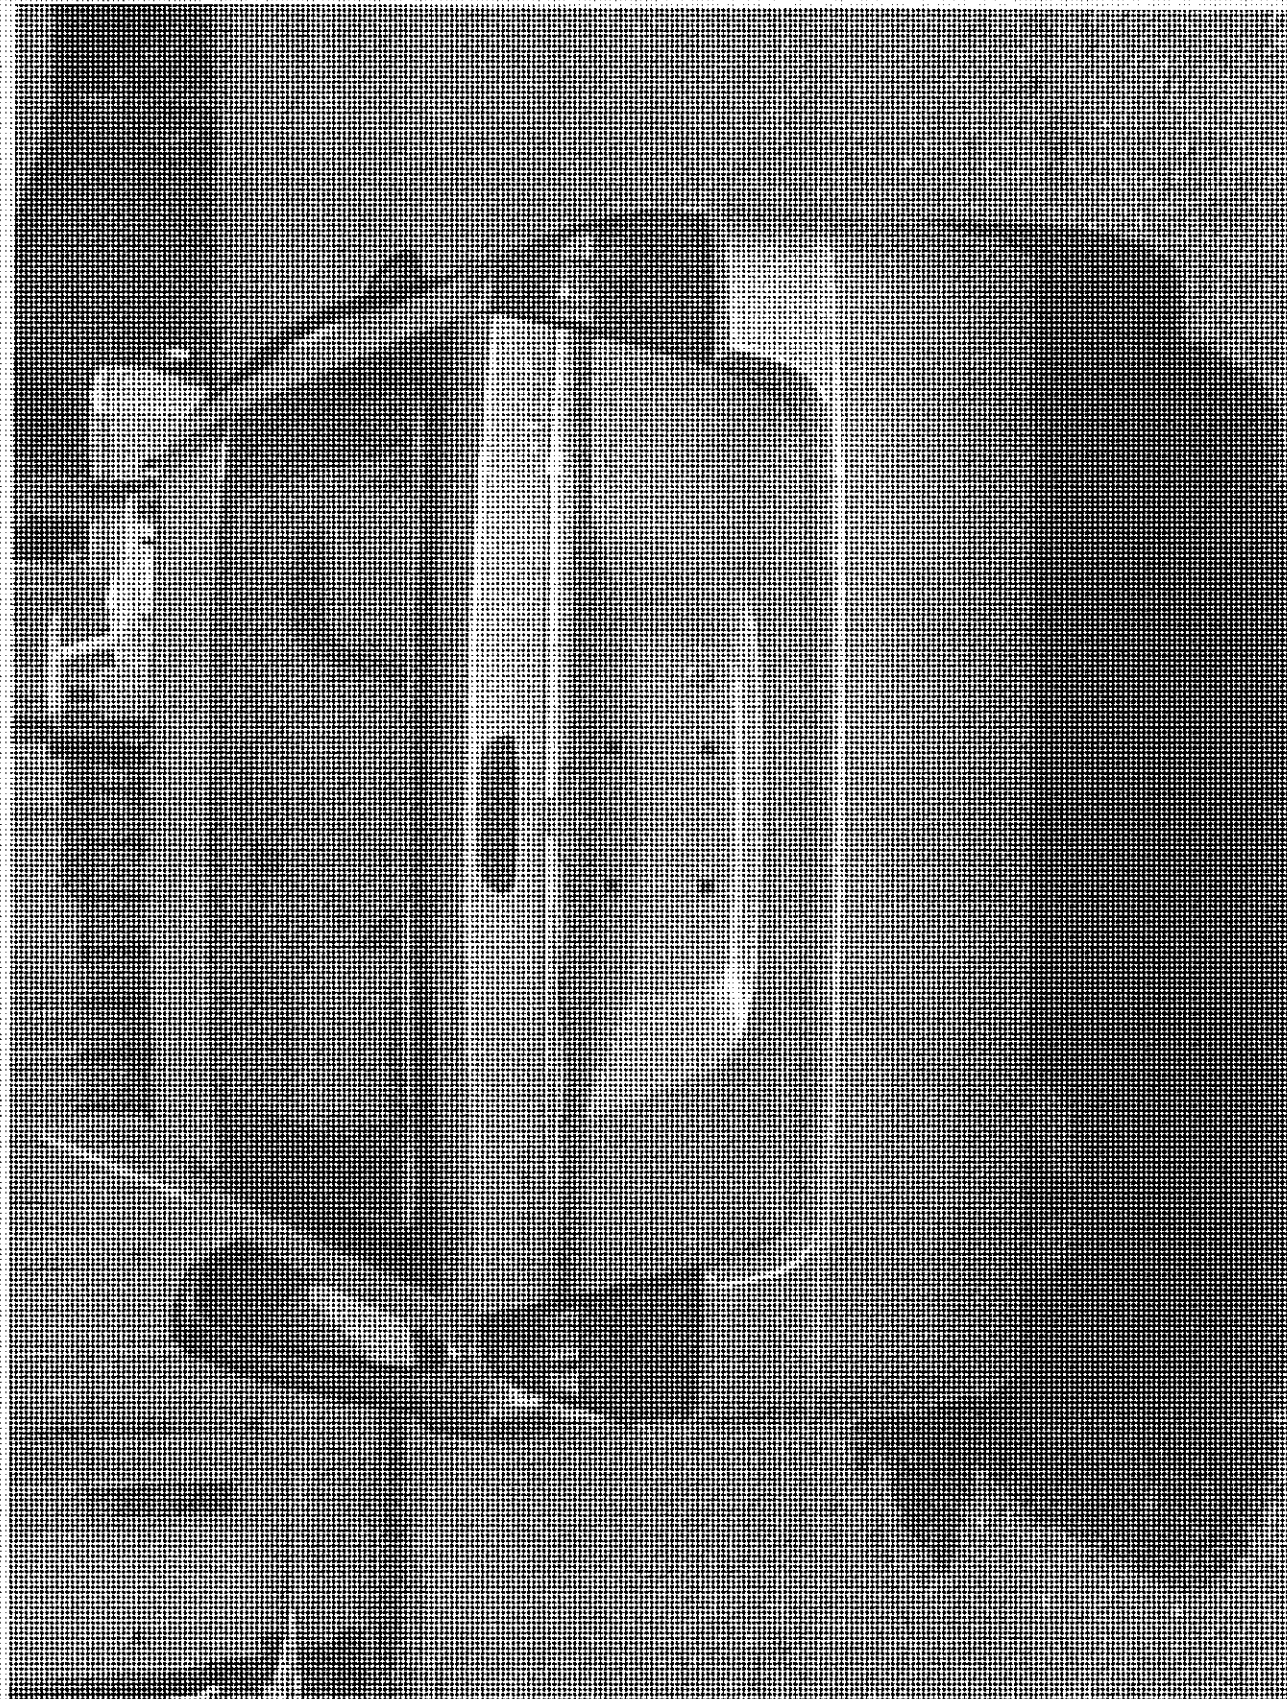
FIGURE 3.34  
REAR VIEW OF VEHICLE POST TEST

| SECTION | | PAGE |
|---|---|---|
| | 5.34 Rear View of Vehicle Post Test | |

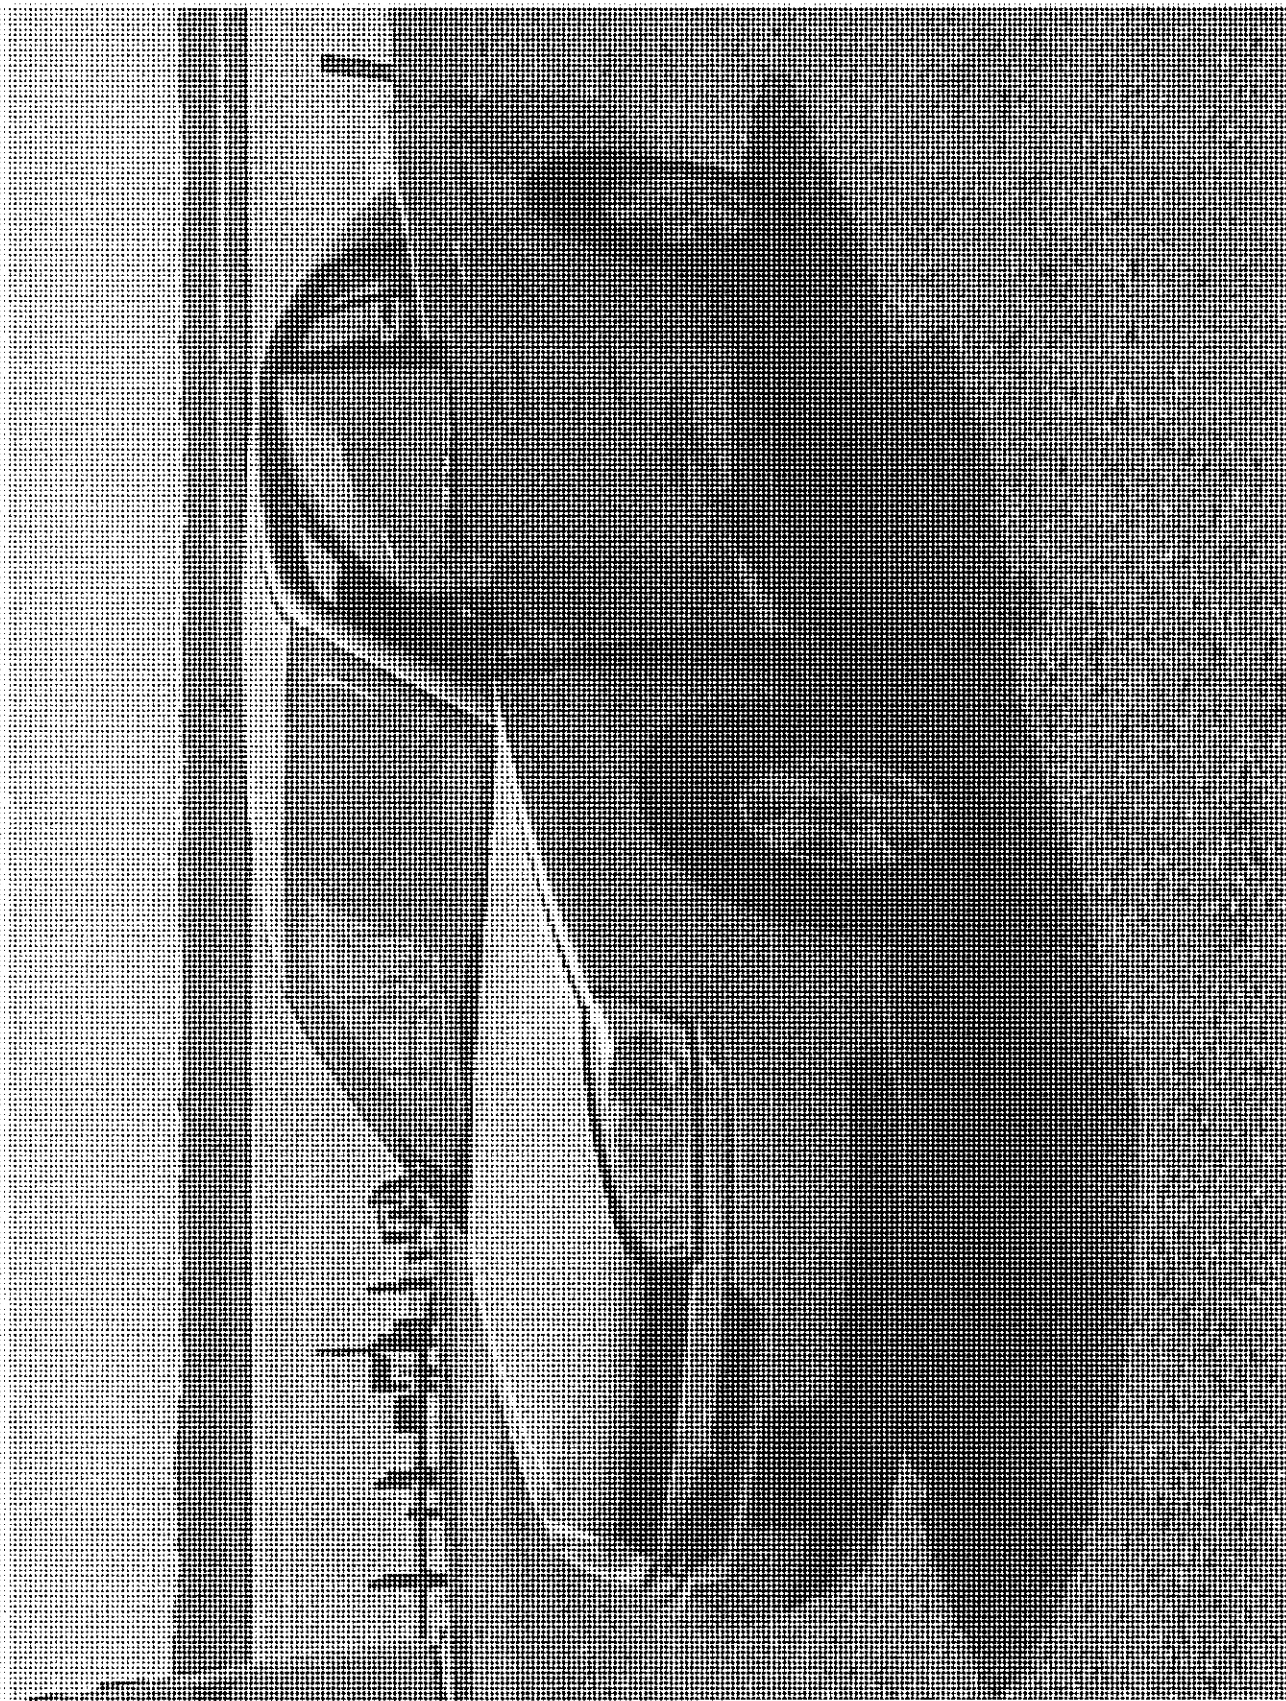
FIGURE 3-35  
¾ FRONTAL VIEW FROM LEFT SIDE OF  
VEHICLE POST TEST

| SECTION | | PAGE |
|---|---|---|
| | 5.35 3/4 Frontal View from Left Side of Vehicle Post Test | |
